# ANNUAL PROGRESS REPORT

ARCHÆOLOGICAL SURVEY DEPARTMENT,  
SOUTHERN CIRCLE,

1908-1909.

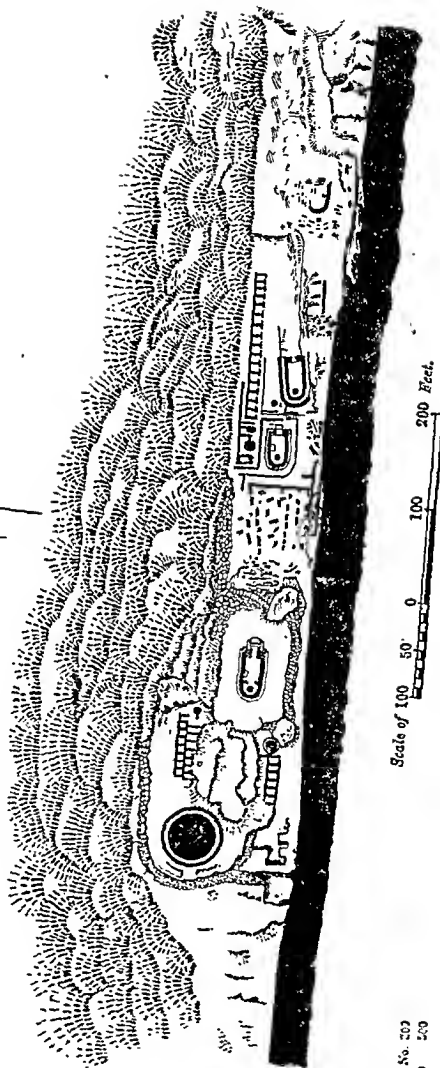
1 No. 203  
200

RUINED BUDDHIST MONASTERY  
RAMATIRTHAM

The excavation so far as it has proceeded has resulted in the unearthing of the following buildings noted consecutively from west to east (Pl. 1). The base of a brick *stupa* at the western extremity 65 feet in diameter, and a tank beside it which was doubtless kept filled with water from the perennial spring on the hill top. Adjoining it on the east is a detached mass of heaped rocks on the east summit of which stands a *chaitya* 55 feet in length. In its apse is a stone *dāgoba* in good preservation except a part of the dome. It contained the stone lid of a relic casket. On the north and south lower sides of the mass of rock are two rows of brick cells each terminated by a small *stupa* or *dāgoba*. East from this again is a pillared hall 77 feet square with rows of massive stone piers all fallen or broken. Two other large *chaityas* with walls still standing for a considerable height adjoin this on the east, and north of them on the outer face of the platform is a long row of cells and other buildings. The other mounds at the east extremity of the platform are as yet only partly explored. A stone statue of Buddha with the graceful flowing robes of the Amāravati sculptures is the only one of the kind as yet found.

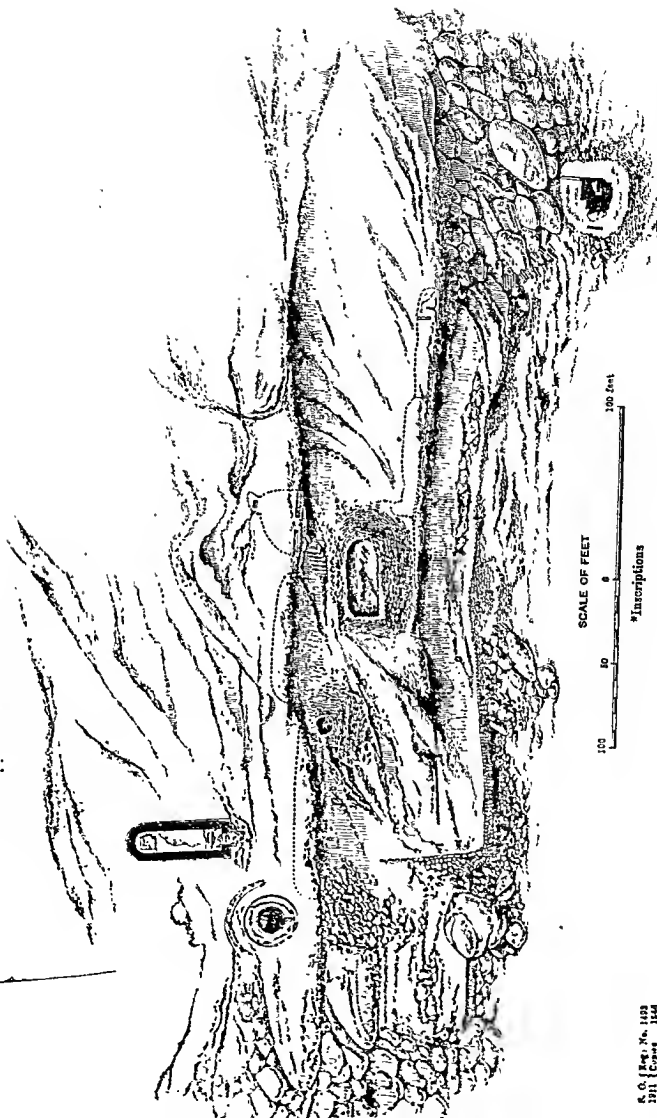
Ruined Buddhist Monastery  
DURGAKONDĀ, RĀMATĪRTHAM.

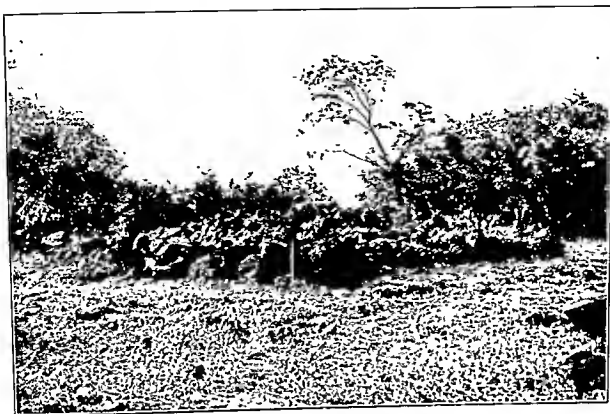
(a) General view of a cairn near Sirumugai.

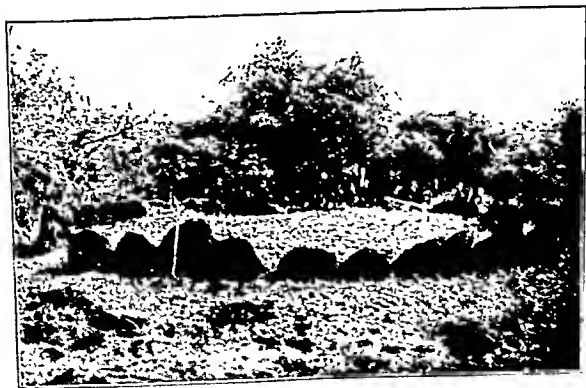
(b) General view of a cairn at Sirumugai.

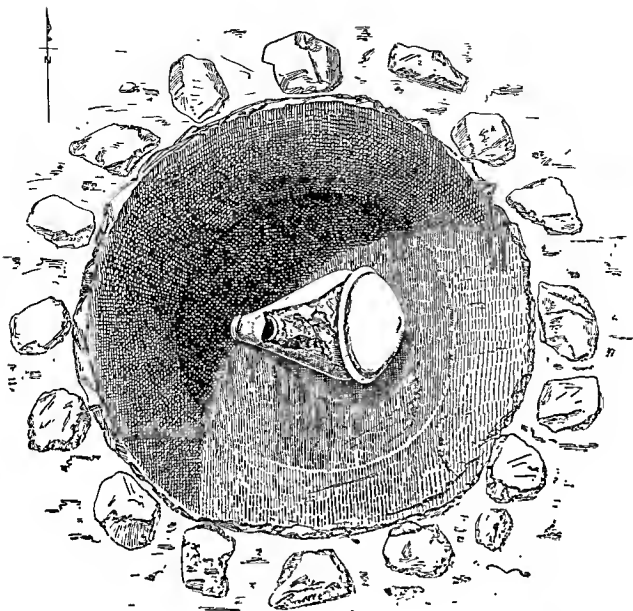
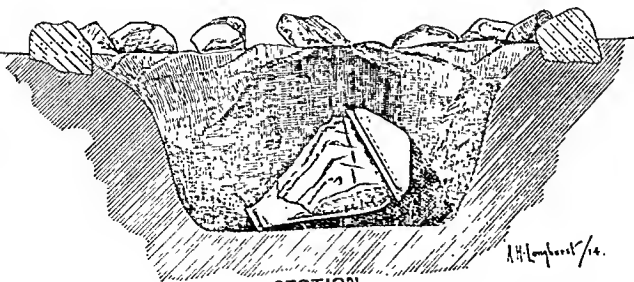
FIG. II.

PLAN.

SECTION

A burial urn found in a cairn near Sirumogai.

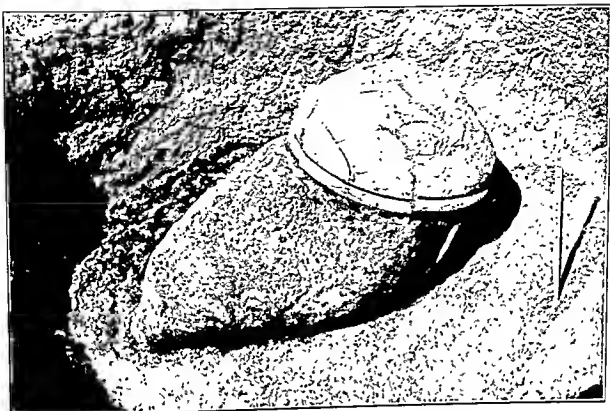
(a) A burial urn found in a cairn near Sirumugai.

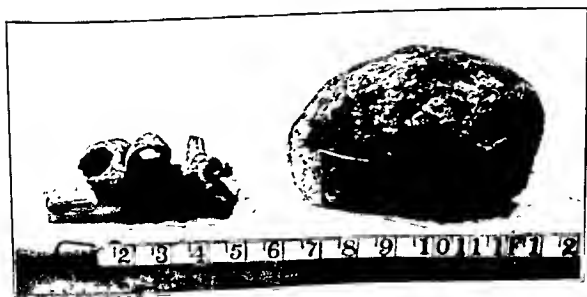
(b) Human skull and bones found in a burial urn near Sirumugai.

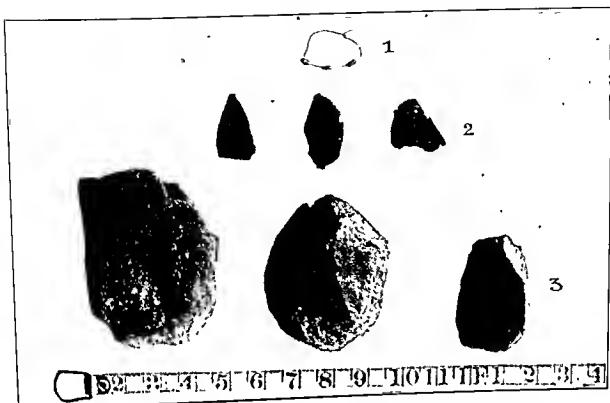
(a) Crystal beads, and iron and stone implements found in a cairn near Sirumugai

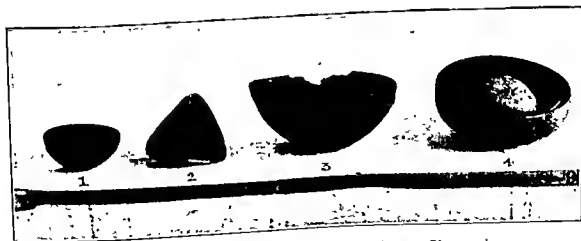
(b) Drinking cups and food bowls found in a cairn near Sirumugai

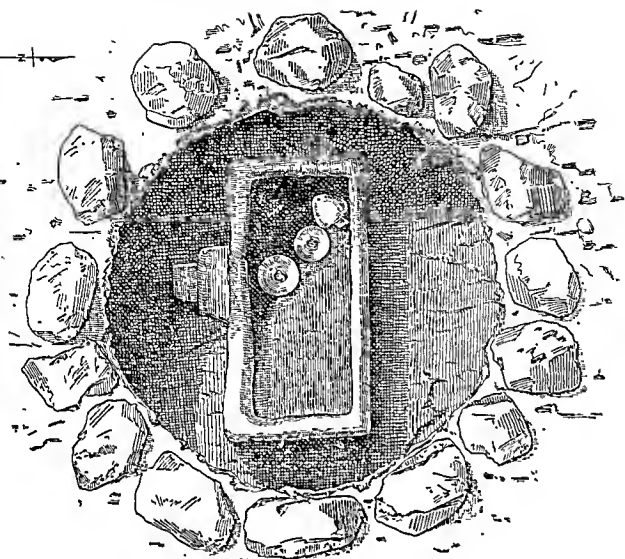
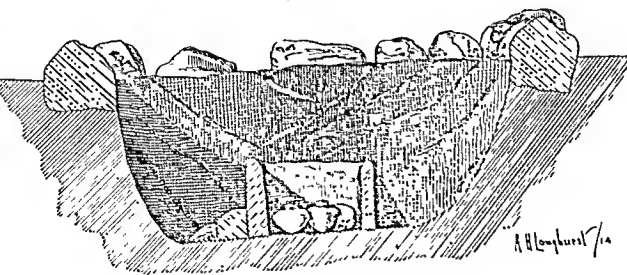
FIG. V.

PLAN.

SECTION.

Rock-cut tomb found in a cairn near Firumagal.

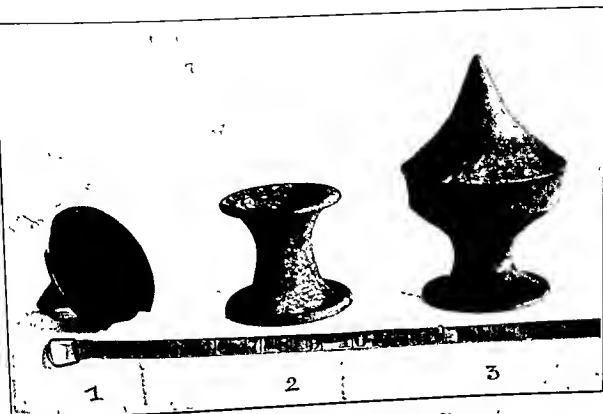
(a) Types of pottery vessels found in a cairn near Sirumugai.

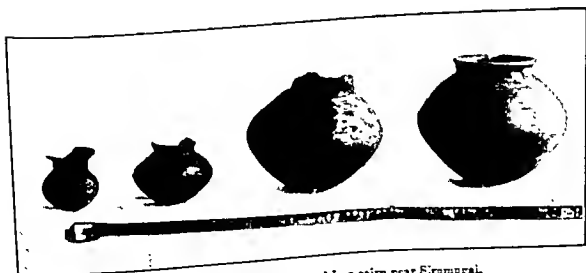
(b) Types of pottery vessels found in a cairn near Sirumugai.

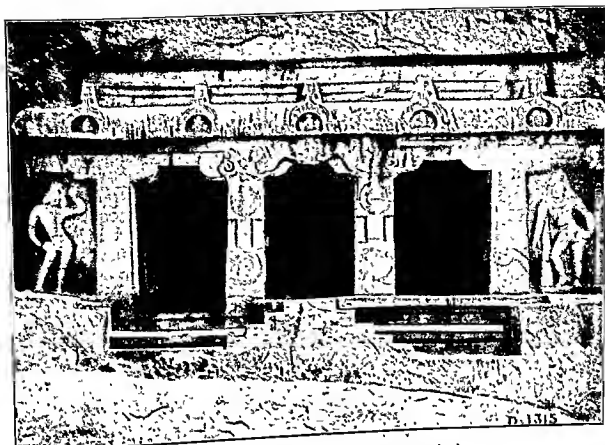
Fig. 1 (a) Dalavānūr temple (Front Elevation).

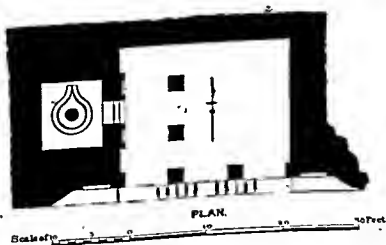
Fig. 1 (b) Dalavānūr temple (Plan).

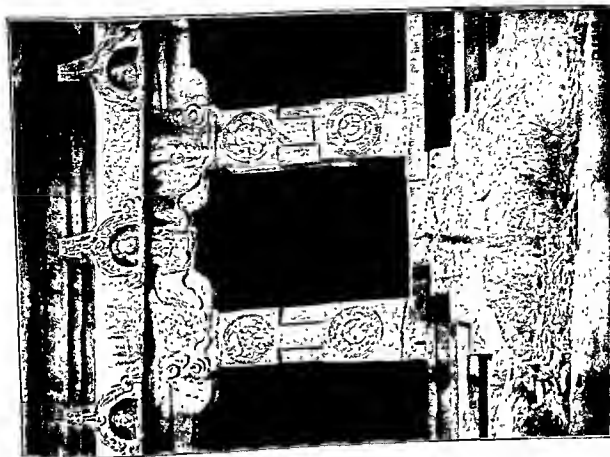
Fig. 2 (b) Dalavānūr temple (Detail of pillars and cornice).

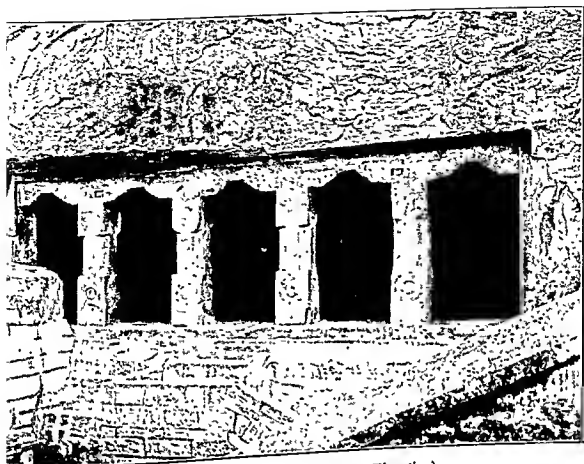
Fig. 3 (A) Trichinopoly temple (Front Elevation).

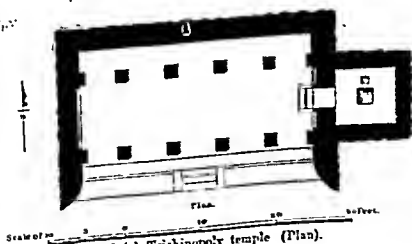
Fig. 3 (B) Trichinopoly temple (Plan).

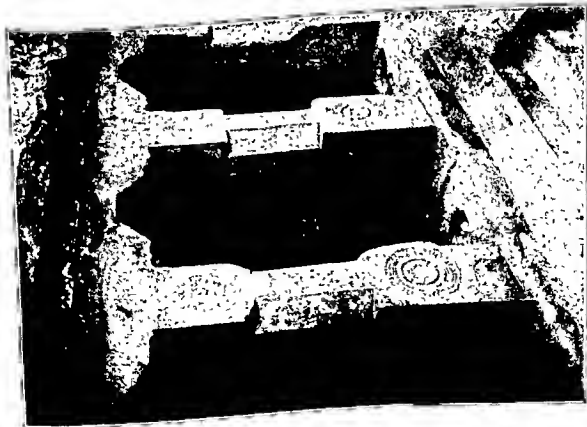
Fig. 4 (A) Trichinopoly temple (Detail of pillars).

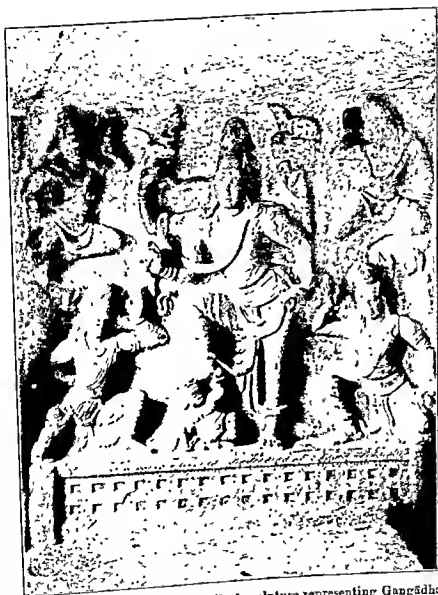
Fig. 5. Trichinopoly temple (Detail of sculpture representing Gangādhara).

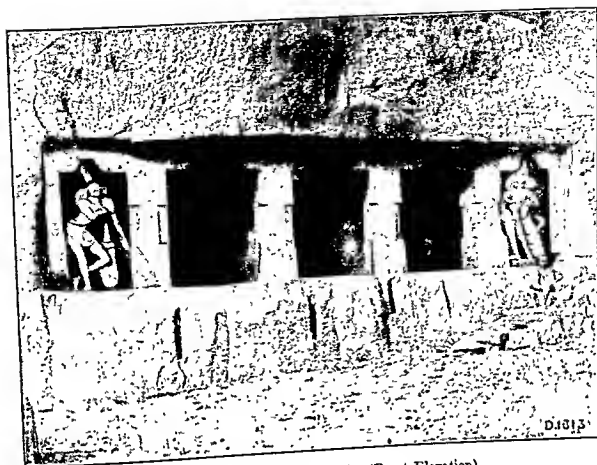
Fig. 6 (a) Mandagapattu temple (Front Elevation).

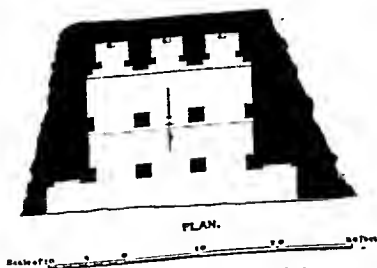
Fig. 6 (b) Mandagapattu temple (Plan).

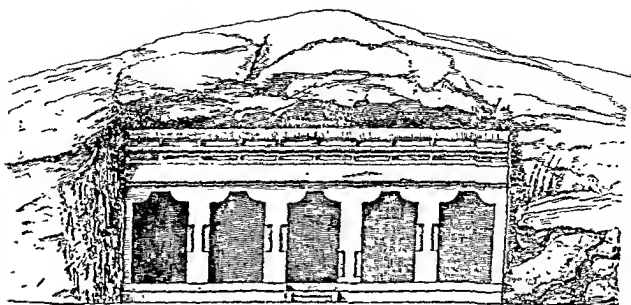
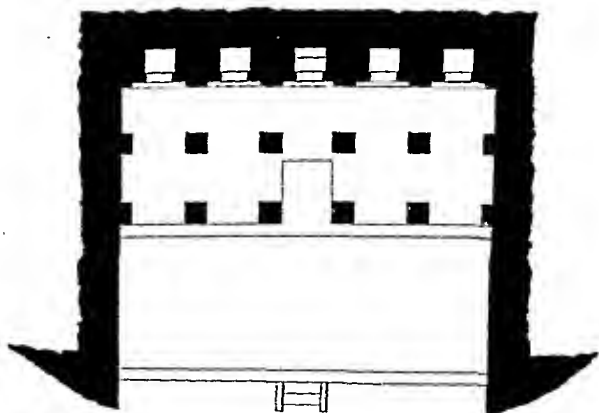
Elevation.

Plan.

Fig 7. Pallikarum temple. (Elevation and Plan).

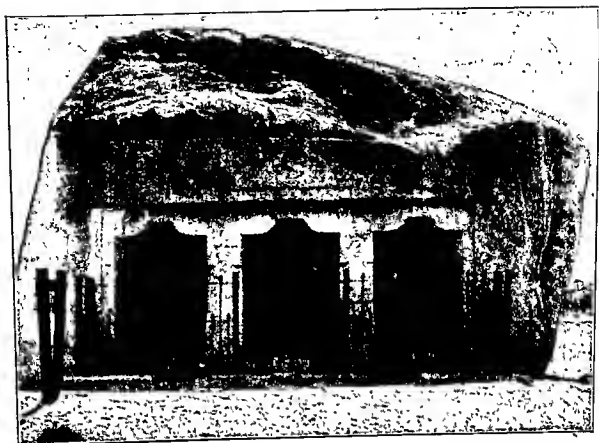
Fig. 8 (A) Mahendravarshi temple (Front Elevation).
